## **Reasons for Leakage of Pressure Control Valve of Pressure Regulator in Nuclear Power Station**

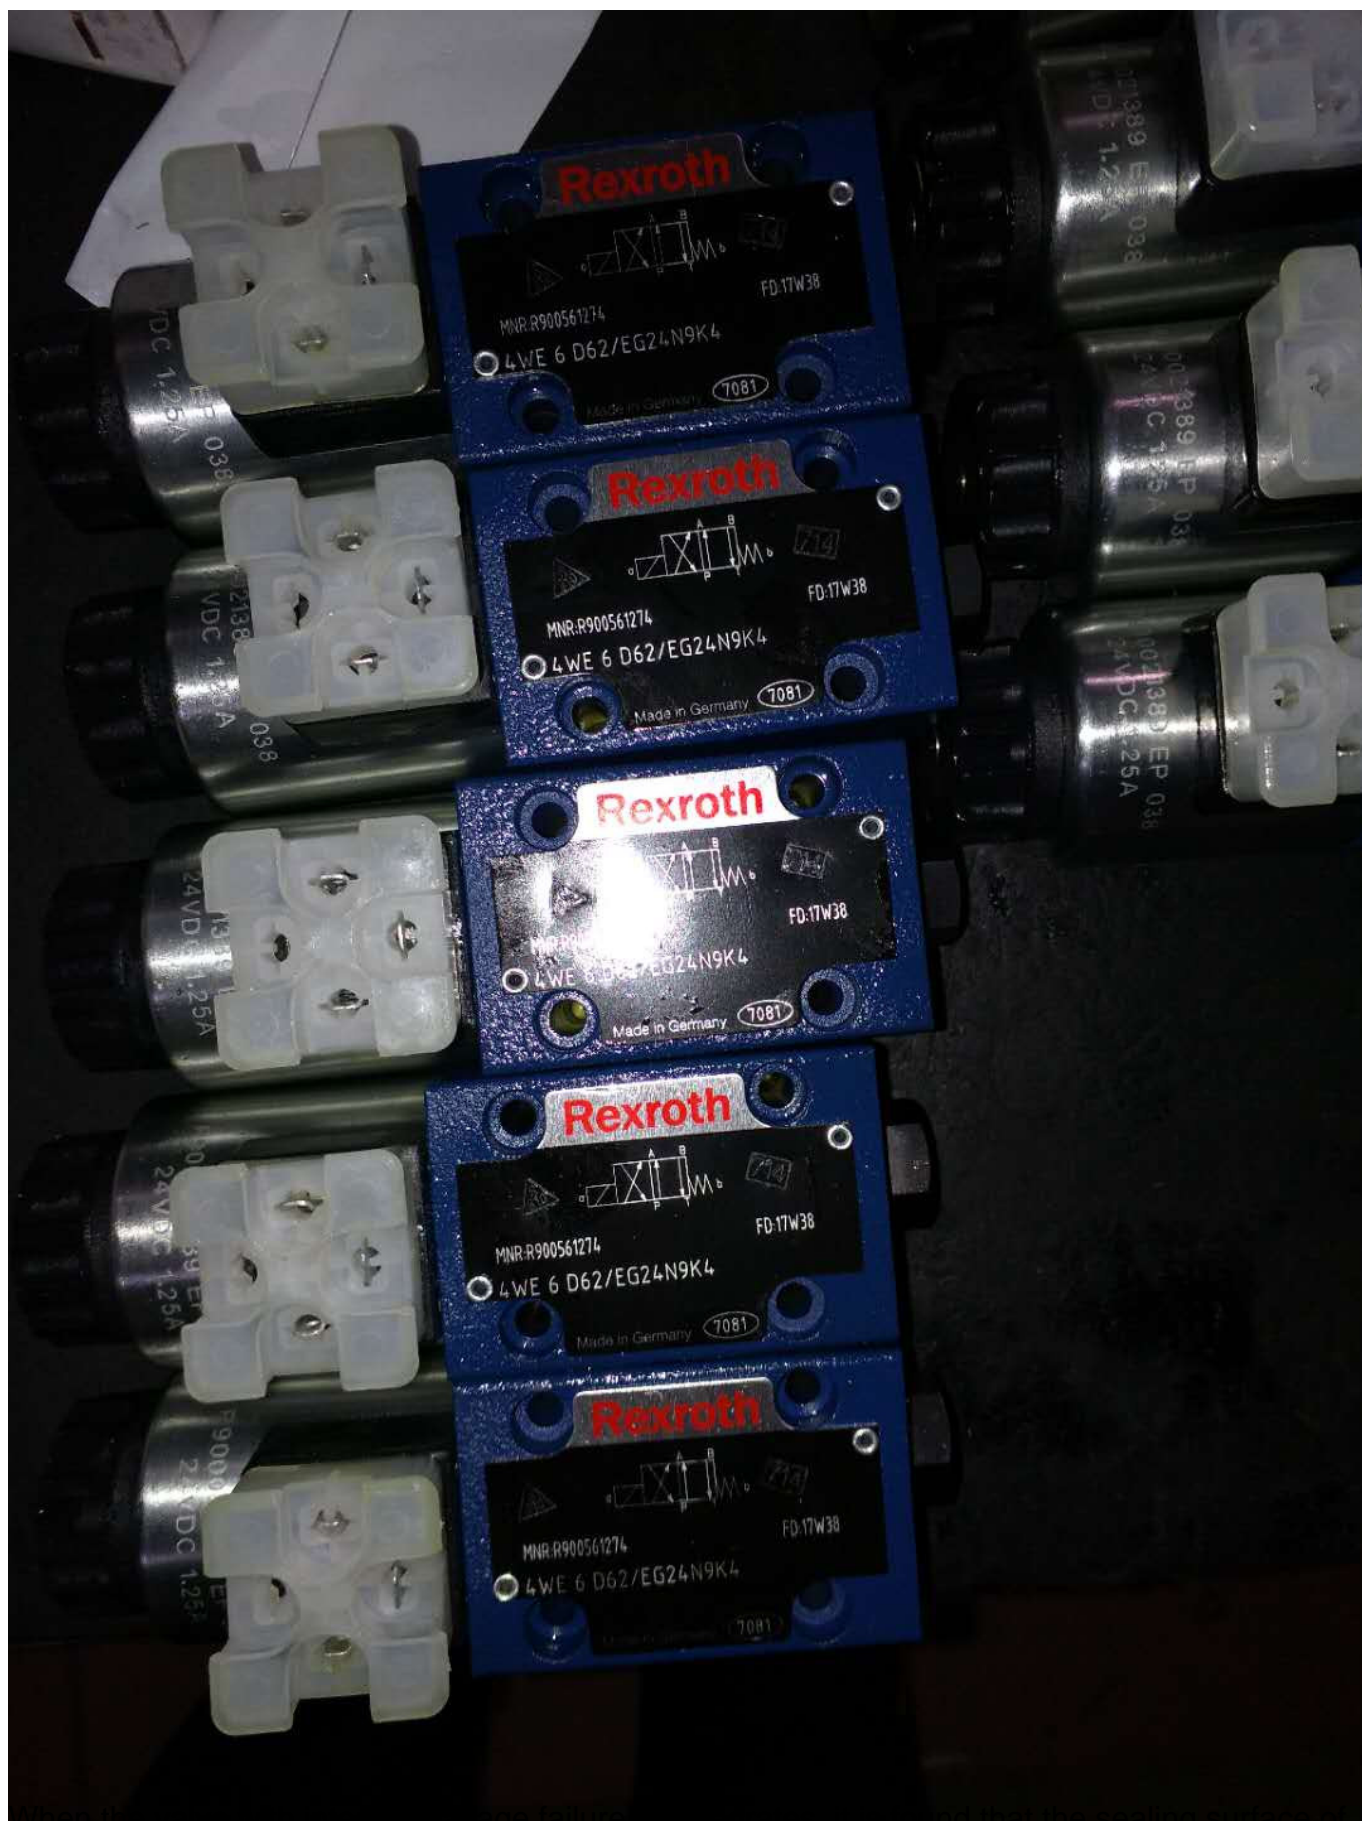
the valve core seat is damaged, which is characterized by dense medium scouring grooves. In the closed state, the valve medium can still leak along the flushing groove. According to the groove depth of the sealing surface of the valve core seat, the damage defect of the sealing surface can be eliminated by grinding the valve core seat or replacing spare parts. After loading and putting the valve back into operation, the test is qualified. However, after several months of operation, the valve has an internal leakage fault. Therefore, it can be judged that too fast damage to the sealing surface of [the valve](#) core seat causes frequent internal leakage failure of the valve. It is necessary to analyze the causes of the damage defects of the sealing surface of the valve core seat too fast. During the operation of the unit, when the valve is opened, especially when the valve is just opened, there will be a large noise inside the valve body accompanied by pipeline vibration. It is judged that the noise is the throttling sound of the internal components of the valve to the high-speed medium steam. At the same time, the valve switch operates frequently during the replacement period of the unit. According to the working conditions of the above valves, the following reasons are analyzed for the failure of the sealing surface of the valve core seat too quickly:

1. The medium pressure at the inlet of the valve is regulator pressure, about 9.93 MPa, and the medium pressure at the outlet is degassing condenser pressure, about 1.05 MPa, and the pressure difference between the inlet and outlet is nearly 9 MPa. When the valve is in a small opening state and the pressure difference between the inlet and outlet is large, the pressure drop of the high temperature medium steam impact valve almost all concentrates on the sealing surface. Especially when the valve is just opened, the maximum pressure difference is 8.88 MPa, and the velocity of the sealing surface of the valve seat is up to 200 m/s. High-speed medium steam scouring results in damage to the sealing surface, and the field performance is that there is a large noise inside the valve body. At the same time, once there is a small leakage point, the medium will continue to wash the leakage point, leading to the expansion of the leakage point, and ultimately make [the valve](#) core seat sealing surface groove damage.

2. Frequent valve switching during the refueling period causes the valve sealing surface to be damaged too quickly. When the unit is refueling, the loading and unloading opportunity injects medium into the fuel passage, which increases the loading capacity of the whole system, which shows that the level of the regulator rises. When the liquid level rises, the pressure of the regulator rises by compressing the air space of the regulator. When the pressure reaches 9.93 MPa, that is, the header pressure at the outlet of the reactor exceeds the normal value of 41 kPa, and the valve opens and lowers the pressure. During refueling, steady Pressure control valves of pressure regulators are continuously switched on and off to maintain constant pressure. Only the replacement of the unit results in 600 valve switching actions per month. The valve opens frequently and the opening time increases, which creates conditions for the high-speed medium steam to wash out the sealing surface of the valve seat.
